TECHNICAL REPORT REMR-CO-3

**CASE HISTORIES OF CORPS BREAKWATER
AND JETTY STRUCTURES**

Report 9

SOUTHWESTERN DIVISION

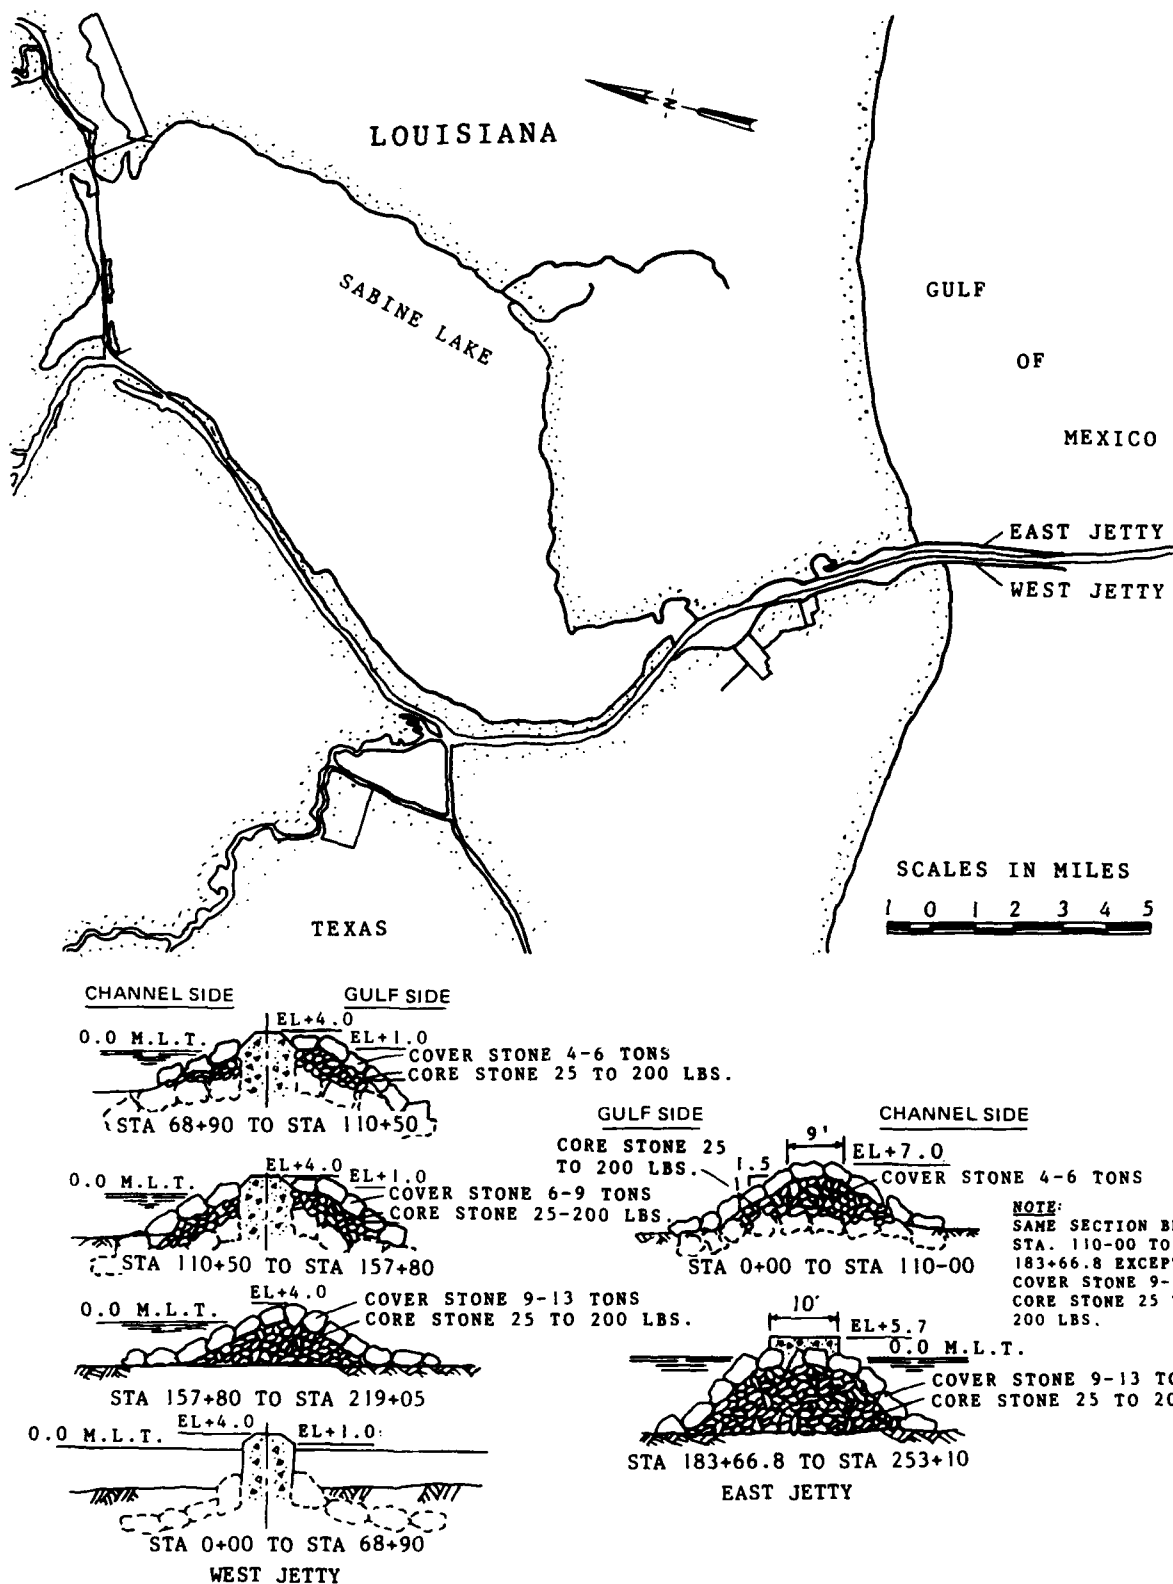
Figure 2. Location map and typical cross sections of Sabine Pass jetties

1986	No work has been done on the jetties since the 1960's, and they are considered to be in good condition, except for a 6,000-ft section at the west jetty's shoreward end.

Date(s)	Construction and Rehabilitation History
1920	The east jetty was completed to its project length of 25,270 ft and an elevation of +5 ft mlg using 44,370 tons of stone.
1924-1928	The west jetty was raised and extended to its project length of 21,860 ft and elevation of +4 ft mlg. A total of 27,860 sq yd of mattress and 178,700 tons of stone was placed. The approximate total cost for jetty completion was \$860,000. As constructed, the jetties are slightly converging to an opening 1,800 ft wide at their seaward ends (Figure 2).
1930-1934	Repairs were made to the jetties by adding stone and resetting existing cover stone. The 5,400 reset stones were to weigh a minimum of 2 tons each. A total of 67,700 and 26,100 tons of stone was placed on the east and west jetties, respectively. The east jetty repairs were carried out between sta 129+15 and sta 240+95. Costs and locations of west jetty repairs are unknown.

1936-1941	The jetties were capped with concrete. The east jetty cap, placed from sta 183+67 to sta 253+10, had an elevation of 5.7 ft mlt and a top width of 10 ft. The west jetty cap was placed on the existing cap to an elevation of +4 ft mlt and an overall width of 10 ft. Stone totaling 23,130 tons and 15,070 cu yd of concrete were placed at a total cost of \$608,000.
1957-1958	The west jetty was repaired using 60,200 tons of stone at a cost of \$834,800 (location of repairs unknown). Cover stone weighed 9 to 13 tons each, and core stone weighed 25 to 200 lb each.
1960-1966	Repairs were made from sta 60+00 to sta 183+67 and sta 68+00 to sta 179+50 on the east and west jetties, respectively (Figure 2). The east jetty was brought up to +7 ft mlt with a 9-ft crown width and 1V:1.5H side slopes. A similar cross section was used on the west jetty from sta 68+00 to sta 90+75 with the cover layer placed over the concrete cap. The remainder of the west jetty cap section was raised with core stone to +1 ft mlt, 1V:1.5H side slopes and covered with armor stone. The core stone varied from 25 to 200 lb. The cover stone varied from 4 to 13 tons between the landward and seaward ends of the repairs, respectively. A total of 430,000 tons (approximate) of stone was placed at a total cost of \$3,961,000.

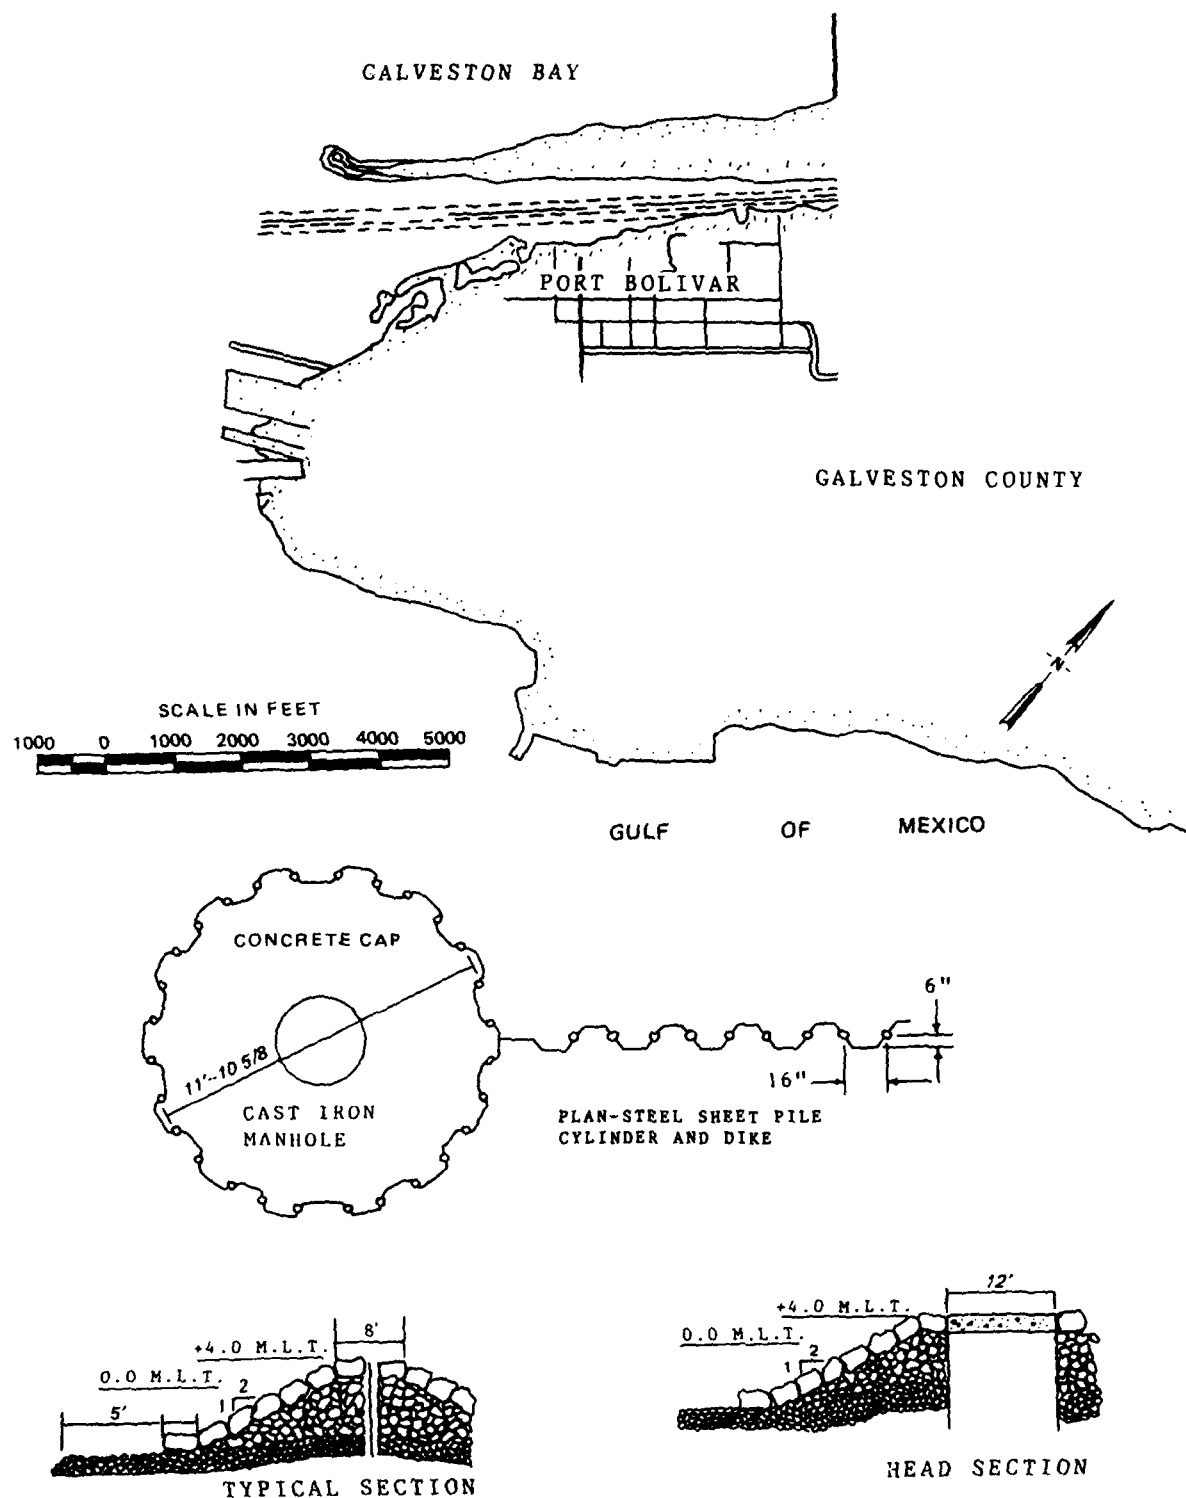
Figure 3. Location, plan view, and typical sections of Port Bolivar jetty

1985	The dike presently is considered to be in good condition.

Date(s)	Construction and Rehabilitation History
1933- 1934	A 1,700-ft-long steel sheet-pile dike was constructed to prevent shoaling in the Gulf Intracoastal Waterway at this location (Figure 3). The seaward end of the dike consisted of a 12-ft-diam sheet-pile cell, with a 2-ft-thick concrete cap (and underlying fill material), protected by a stone blanket at the toe of the cell. The top elevation of the sheet pile was +4 ft mlt. Existing water depths varied from -4 (landward) to -13 (seaward) ft mlt. A total of 47,500 sq ft of sheet pile and 6,670 tons of stone was used. Cost of the improvements was \$25,000.
1936- 1937	The landward end of the dike was repaired and extended 200 ft at a cost of \$7,050. Approximately 230 tons of stone was placed as scour protection at the seaward end at a cost of \$1,750.
1966	The outer 1,230 lin ft of sheet pile was supplemented with a rubble-mound section similar to the 1964-1965 Port O'Connor repairs. The dike was generally intact, with some damage to the piling at the outer end and a heavy coating of rust scale due to saltwater exposure. Existing ground elevations varied from -5 ft mlt near the seaward end to +4 ft mlt along the unrepaired landward segment (in general, an accretion of 6 to 8 ft had occurred since original construction). The outer sheet-pile cell, with a maximum water depth of -11 ft mlt, was the only section where localized scour was evident (but in this case not critical to structural integrity). The sheet-pile top elevation was generally from +3.5 to +4 ft mlt (within 0.5 ft of the design elevation). The rubble-mound design sections (Figure 3, inset), with the existing dike at the center line, had a crown elevation varying from +4 (seaward) to +6 (landward) ft mlt, a crown width of approximately 8 ft (2 cover stones wide) and 1V:2H side slopes. The sections were built upon a 2-ft-thick (3 ft at outer end) bedding layer of 0.5-in. to 200-lb stone. The bedding layer extended from 3 ft (landward) to 10 ft (seaward) beyond the toe of the cover layer and was covered with a 2-ft-thick layer of 200- to 1,000-lb apron stone. Similar sized stone were used as core stone, and the outer layer consisted of 1- to 6-ton stone. Filler stone (0.5 to 4 in.) also were placed with the core stone, in a section extending beneath the crown at 1V:1H side slopes. The general purpose of filler stone is to decrease permeability and reduce sediment transport through the structure. The cover stone size was selected based partly on Hudson's slope stability equation and partly for economic reasons. A total of 19,280 tons of stone was placed at a cost of \$164,700.

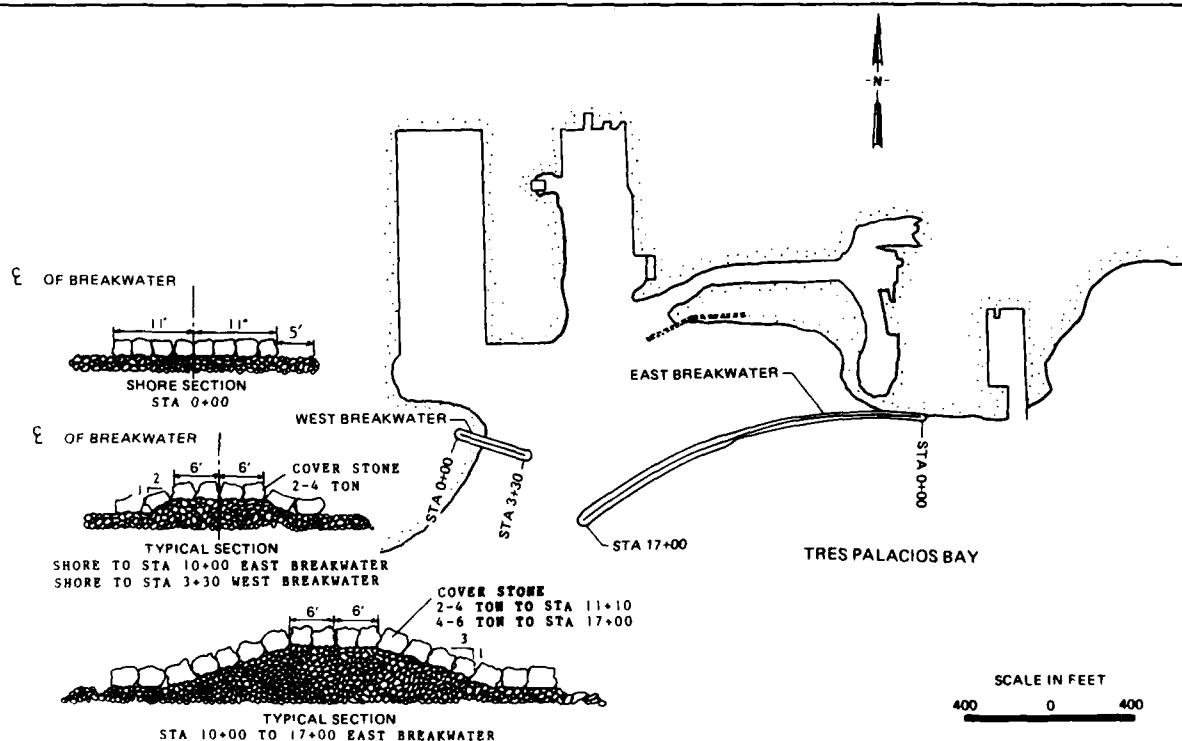
Figure 8. Plan view of Palacios Harbor and typical breakwater cross sections

1970	The shoreline, made up of clay banks, was eroding in the general vicinity of the west breakwater. Rubblestone was placed along the shoreline on either side of the breakwater. (No details are available.)
1983	The breakwaters were inspected and considered to be in good condition.

Date(s)	Construction and Rehabilitation History
1966	Two rubble-mound breakwaters were constructed to lengths of 1,700 and 330 ft on the east and west sides, respectively, of the Palacios channel entrance (Figures 6 and 8). The purpose of the structures was to reduce wave energy entering the harbor and shoaling in the harbor slips and entrance channel. The breakwaters were constructed with a core and 2-ft-thick bedding layer of 0.5-in. to 200-lb stone. The core stone was placed to an elevation of +2 ft mlt, a width of 12 ft, and side slopes of 1V:3H and 1V:2H on the outer 700 ft of the east and remaining breakwater sections, respectively. A single layer of 2- to 4-ton cover stone was used on the breakwaters, with the exception of the outer 590 ft of the east breakwater which was covered with 4- to 6-ton stone. Some toe protection was provided by placing one to two cover stones at the base of the side slopes and extending the bedding layer 5 ft beyond the cover stone.

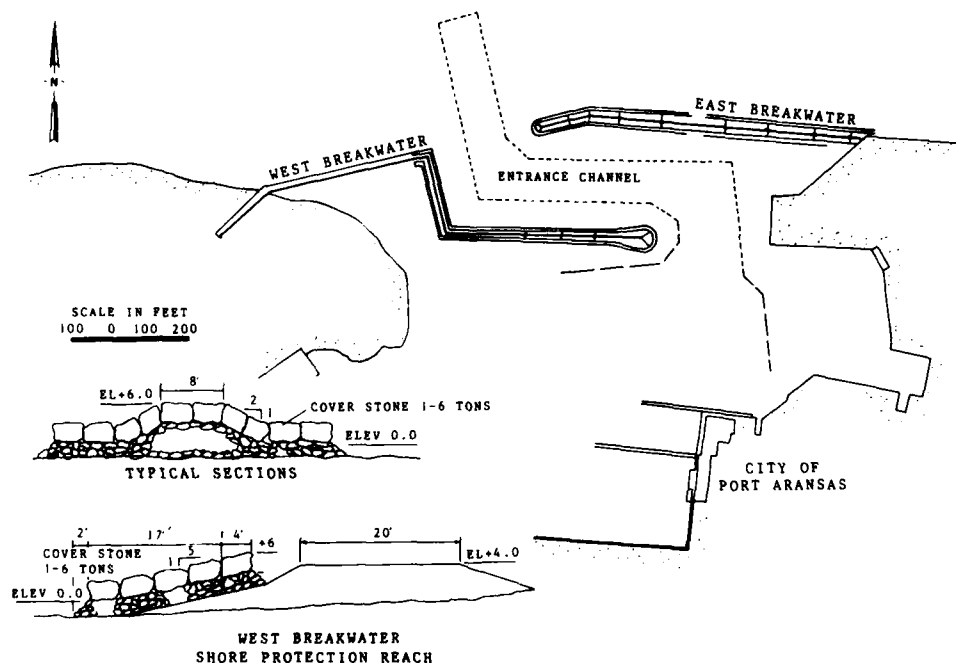
Figure 12. Port Aransas plan view and typical breakwater sections

1977	<p>An inspection of the breakwaters indicated they were in good condition with the exception of the revetted section of the west jetty. Waves breaking over the shore protection had eroded the sand fill resulting in some minor settlement of the stone.</p>
1984	<p>The breakwaters were inspected and considered to be in good condition.</p>
